By Hank Bruflodt

# MAXIMUM PERFORMANCE

## Avoiding slab moisture problems is crucial in healthcare

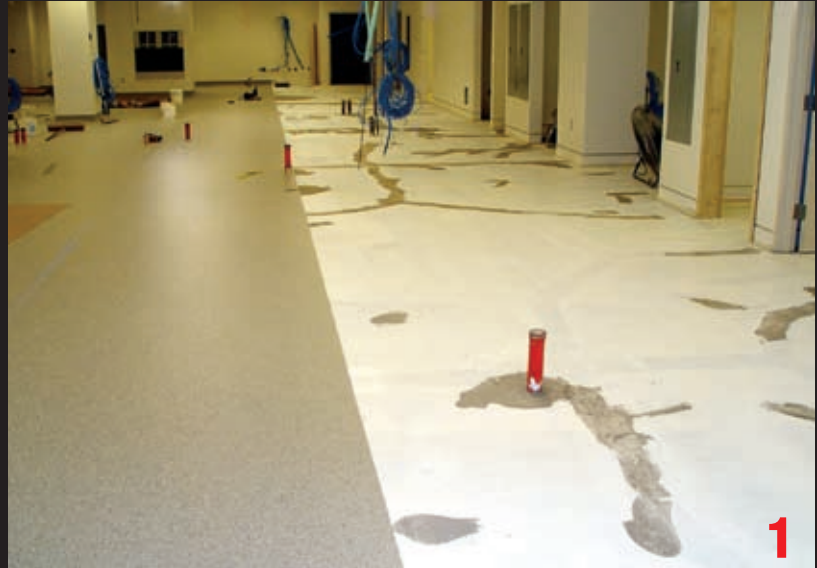
**1. A brand new floor (left side) installed over a properly sealed concrete slab. Patches are cement compound used to make the surface smooth.**

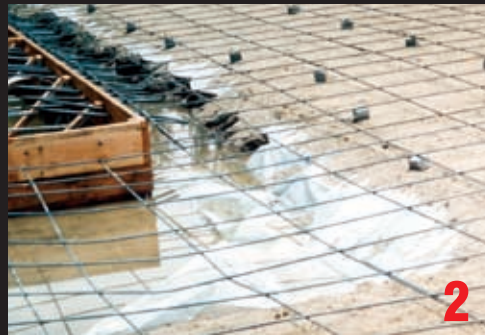
**2. Plastic sheets or vapor retarders under the slab are ineffective when the sand fill is first covered by rain water.**

When a slab is poured on the ground, it is usually placed over a sand layer that is on top of a plastic sheet or over a sand-bed. This plastic sheet is commonly called a vapor barrier, is better termed a retarder. (You can never stop ALL moisture vapor from entering a building, only minimize its volume to where it's not a problem.) This measure is taken to reduce the long-term intrusion of moisture from the ground. Underslab vapor retarders however, have no effect on controlling the moisture that was inside the concrete during its construction that still has to escape.

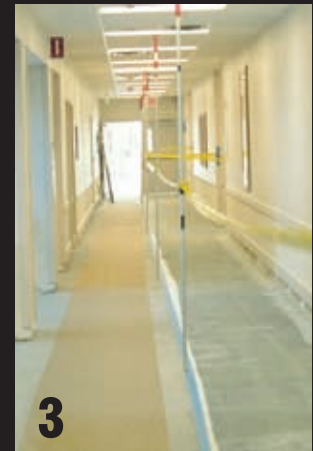
**3. Half the floor is being treated while the other half is being used to transport patients in this Texas hospital.**

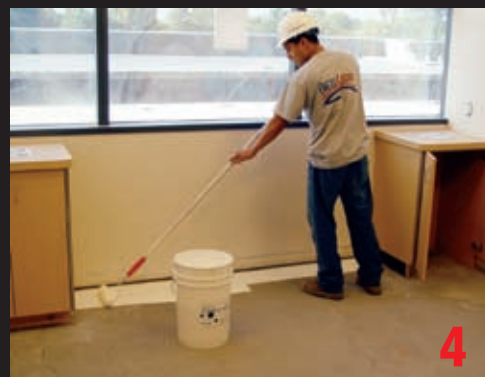
**4. Crewman install a concrete moisture sealer on a new slab at a Southern Californian high rise hospital building.**
